CONSTRUCTION OF THE CONCRET FACE, EL CAJON DAM, NAYARIT, MEXICO

Abstract: The hydroelectric El Cajon, on the Santiago River in western Mexico, was finished in 2007. The 188 m high concrete face rockfill dam is one of the highest in the world. The CFRD, with a 550 m length crest, required 11×10^6 m³ of rockfill. The concrete face needed 55 000 m³ of concrete ($f'c = 25$ MPa), and was built in 4 stages with slipforms of 15 and 7,5 m wide, with a 3-4 linear m/hour rate, for the first, second and third stage, and with wood forms for the last stage. Plinths were built supporting the concrete face in the abutments. The concrete was made in a central mixer plant, transported to the site by revolving drum truck mixers and poured with chutes. The concrete mixture had a 0,50 water/cement ratio and a slump of 8 cm. The slabs had a thickness from 30 to 80 cm. The concrete was cured using membrane and wet burlap. An important issue was the special cupper seals used in the joints between slabs and in the joint with the plinth, in order to avoid infiltrations to the body of the dam. The quality control followed the specifications for the materials and constructive procedures, assuring the qualit

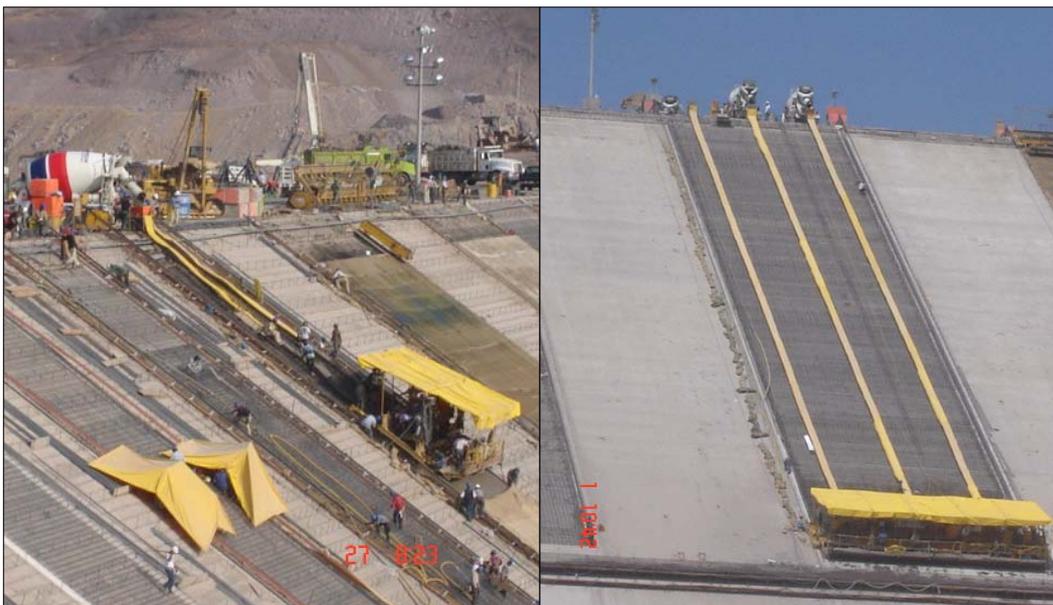
Figure 4. Slipforming the concrete face: lateral and central slabs.

6) Concrete was poured on 3 lines of chutes; the trucks discharged the concrete on feeding boxes, by gravity, the concrete was conducted through the chutes to the slipform. (Figure 4)

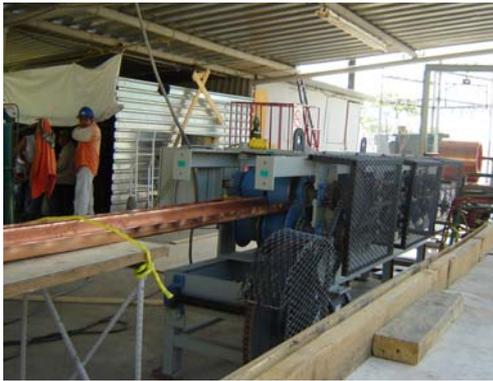
Figure 5. Rolling machine for manufacturing the copper seals, and detail of an extension joint.

copper seals installed between the concrete slabs were fabricated from phosphorated copper sheets 1.02 mm thick, rolled on site (figure 5), avoiding welding as much as possible, and considering 15 mm for overlapping when necessary. The upper seals were anchored to the concrete. Between lower and upper
